Understanding Frost Free Hose Bibs

By Mark Townsend – Home Inspector/Owner - T2 Home Services

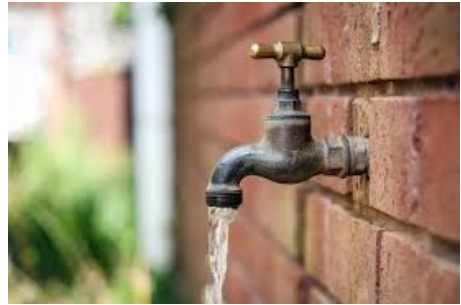
An Exterior Hose Bib, or otherwise called a Sill Cock, is a “[Tap](#)” point to the homes water supply, and is commonly used to connect a garden hose for various uses on the exterior of the home such as watering the lawn or washing the car.

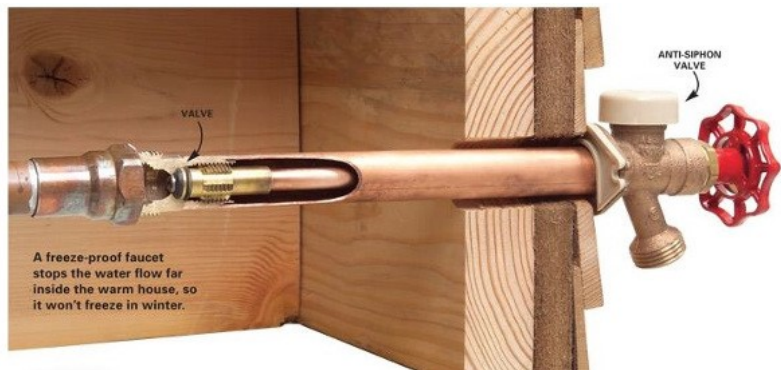
In 1965, a patent was filed by [Nibco Inc.](#), for a “Frost Free” type of hose bib where the shutoff point was relocated from the exterior, to a point that could be placed within the insulated space of the structure.

A tube was attached to the valve, which contains a rod attaching the control handle on the exterior, to a seal at the other end, thus stopping the water flow before it entered the cold space. These are traditionally installed in either a wall or floor cavity that can be insulated with the structure.

Lets first understand how these units are constructed. The most common frost-free hose bibs/sill cocks being sold today consist of a copper or brass tub which contains the shutoff rod and seal, along with a brass “bib” that contains the valve handle and hose connection fitting. Additionally, most units today also are fitted with an Anti-Siphon valve, which will be discussed in a later article. Although the bib, or hose connection is usually made of a thick and hardened brass material that weathers well, the valve tube is generally not. On a majority of these units, this tube is made of a light copper or brass material that does not easily corrode and allows the rubber seal to easily move inside to provide a good seal. Since this part is designed to be inside the conditioned space, the common materials used work very well and as intended.

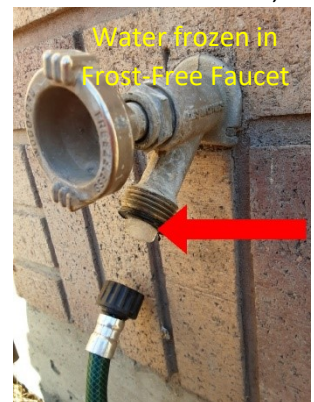
- 2) **Remove hose during freezing weather** – It is recommended by most faucet manufacturers to remove hoses, timers, etc. when not in use, but is even more important on Frost Free units and critical during freezing weather. When the hose is left attached, the faucet cannot drain the valve tube and water is trapped inside a tube that is not designed to freeze. When the water in the hose freezes, it can expand back into the valve tube section and cause it to crack as shown here.

When a frost-free bib cracks during the winter, you may not even realize it until spring. When you turn that faucet on to water the lawn, pressurized water enters the cracked valve tube, and exits into the wall or floor cavity where it is installed, leading to a possibly expensive repair.
